***Hi-Impact 8000 brand Fire-shield
Gypsum Wallboard
5/8" Tapered Edge Type X Core***

***Test #2
Fire inside the wall***

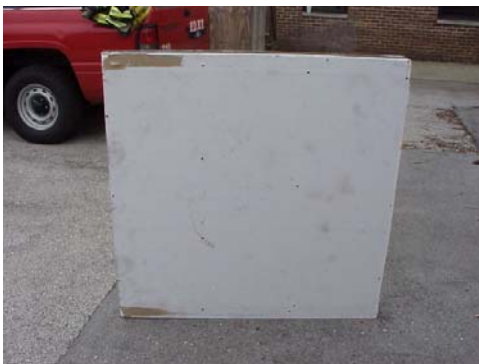
4' x 4' wall with metal stud framing and Hi-Impact 8000 wallboard mounted to both sides of the wall.

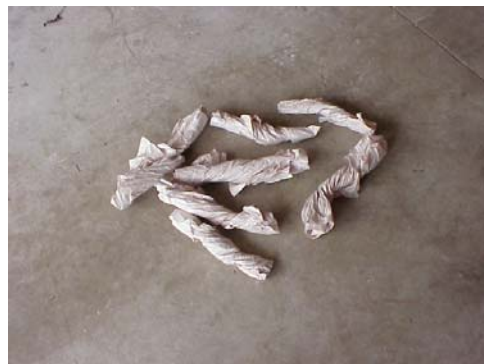
Approximately 4 pieces of white packing paper were ignited inside the wall to simulate burning materials that have dropped into the wall during a structure fire.

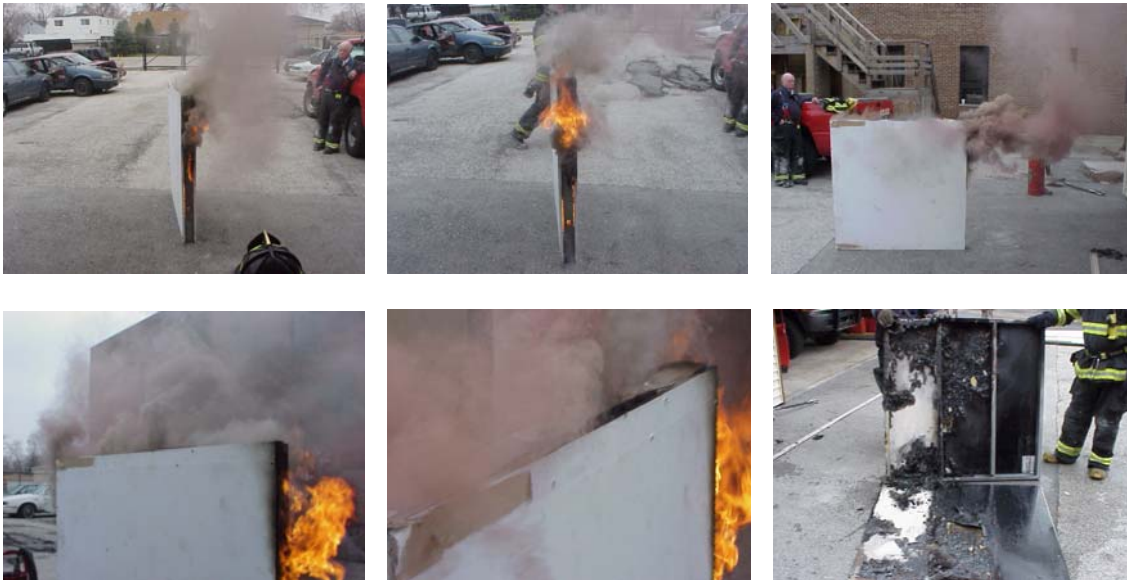
Additional Photos:

After extinguishment, one side of the test wall was removed to evaluate the amount of fire spread inside the wall. The fire completely consumed 1 full bay of the Lexan backing between the stud spaces where the fire was started. The fire then traveled through the pipe chases in the stud to the next bay, consuming the top ½ of the 2nd stud space. It was noted that some of the Lexan that had melted down was starting to ignite the bottom of the wall in the 2nd stud space. The 3rd bay in the test wall suffered very minor damage if any at all.

In conclusion, it was demonstrated that the Lexan backing contributed to the fire spread within the wall. The Lexan backing also created a heavy and multiple colored smoke condition during the burn phase of the test.
