***Hi-Impact 8000 brand Fire-shield
Gypsum Wallboard
5/8" Tapered Edge Type X Core***

***Test #1
Wall Breach***

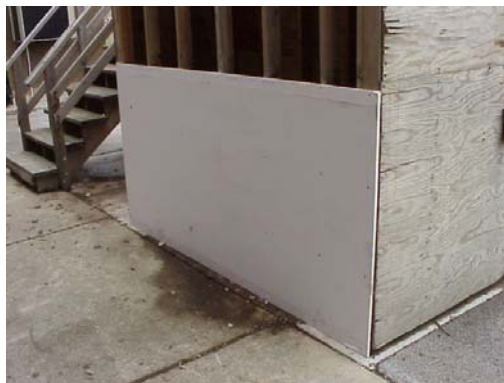
The test was conducted by utilizing 5 different hand tools that a firefighter will most likely have with him during firefighting operations. Each of the 5 different hand tools was used to attempt to breach the Hi-Impact 8000 Wallboard. The wall was constructed of wooden studs on 16" centers. The 4' x 8' sheet of wallboard was mounted to the studs using ordinary drywall screws. The wall is pictured below:
